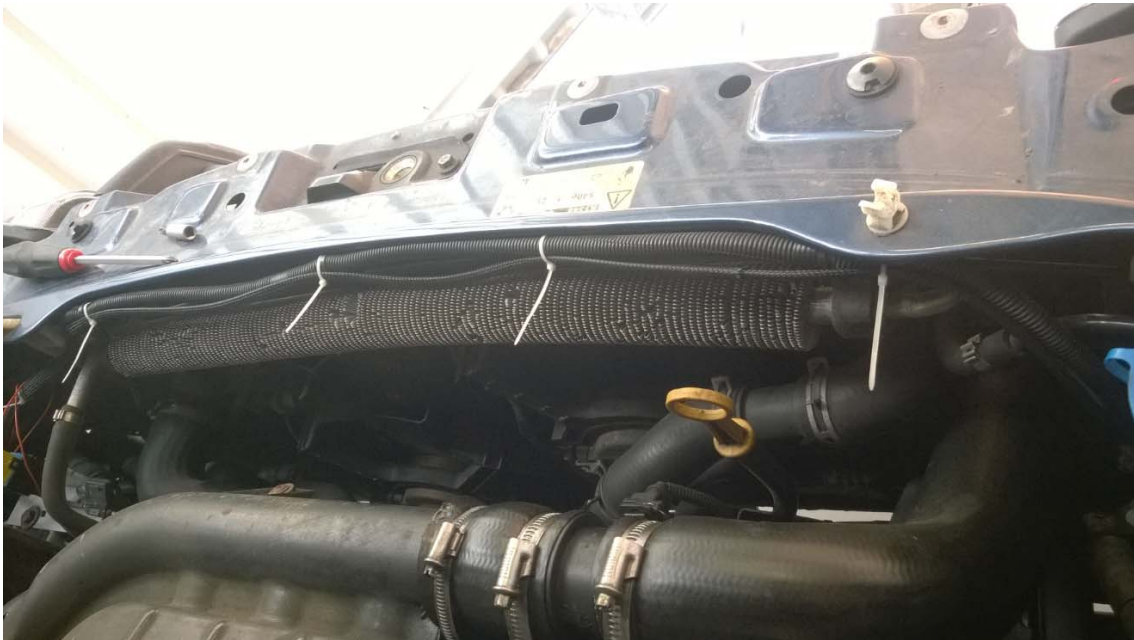
I ran the single wire up and across the top of the oil cooler with additional braiding for protection

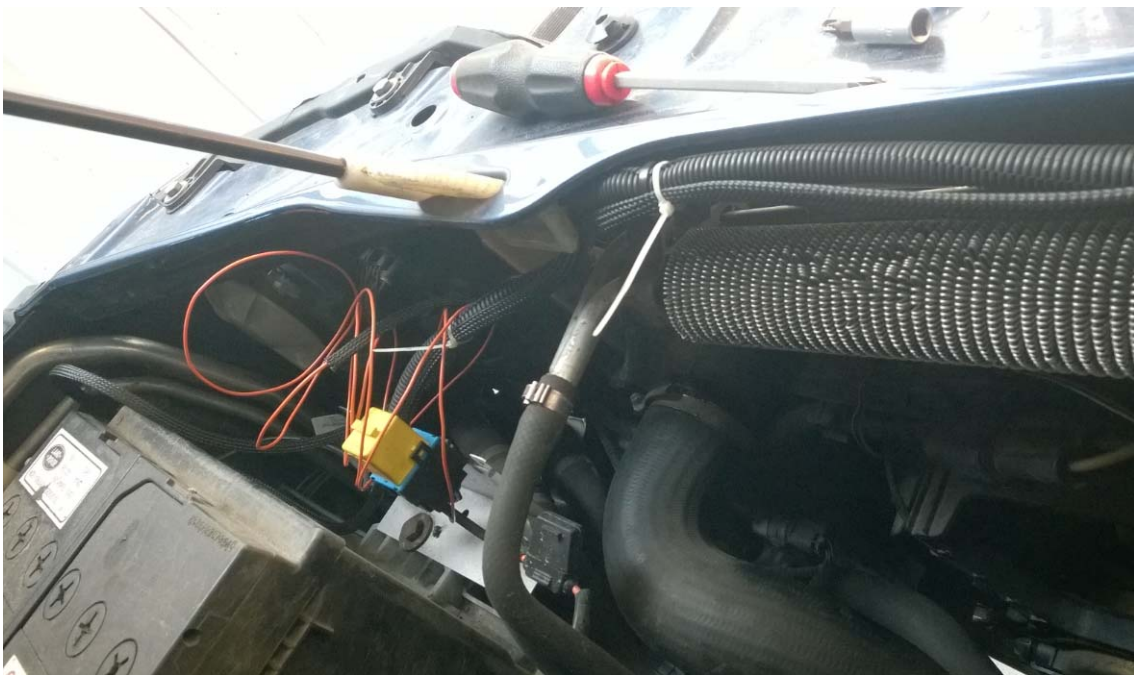
Run the cable round past the battery and work towards the engine bay bulkhead where underneath the engine bay fusebox there is a large grommet with a teat that can be cut off to allow additional accessories to be fitted, Lubricate wire with silicon grease to ease passage through bulkhead grommet. Once wire is inside cabin run across and behind heater console and up into the instrument pack binnacle area, connect to instrument. Refit instrument pack.

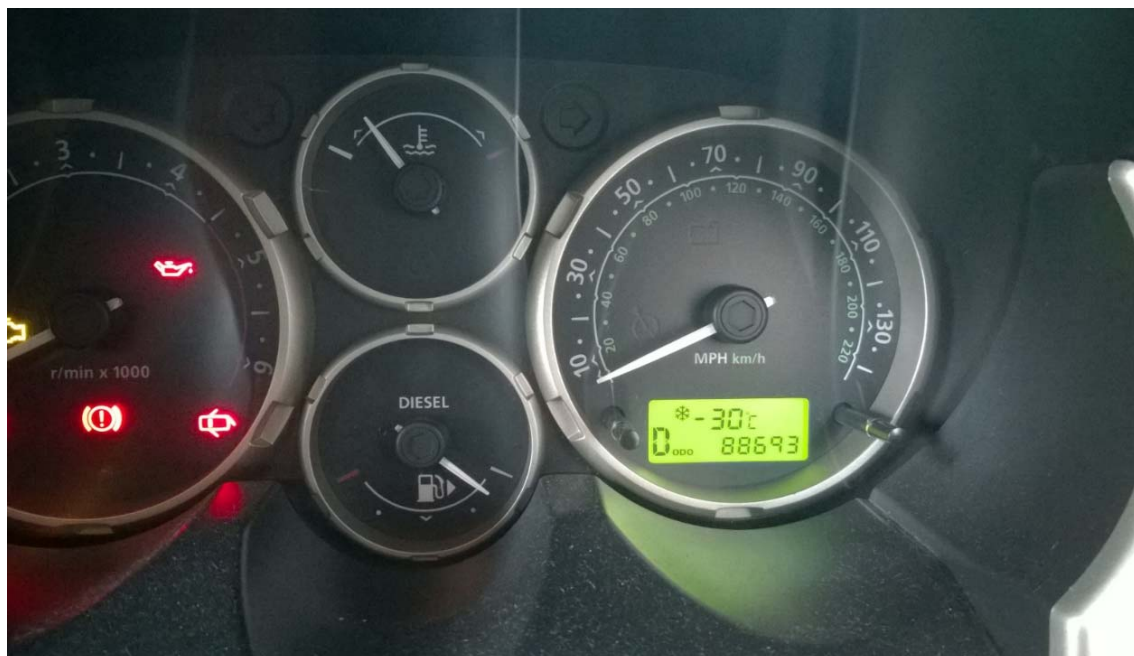
Once the T4 session is completed you should end up with the temp display showing -30degC. You don't have to do it in this particular order, The T4 session can be done at any time.

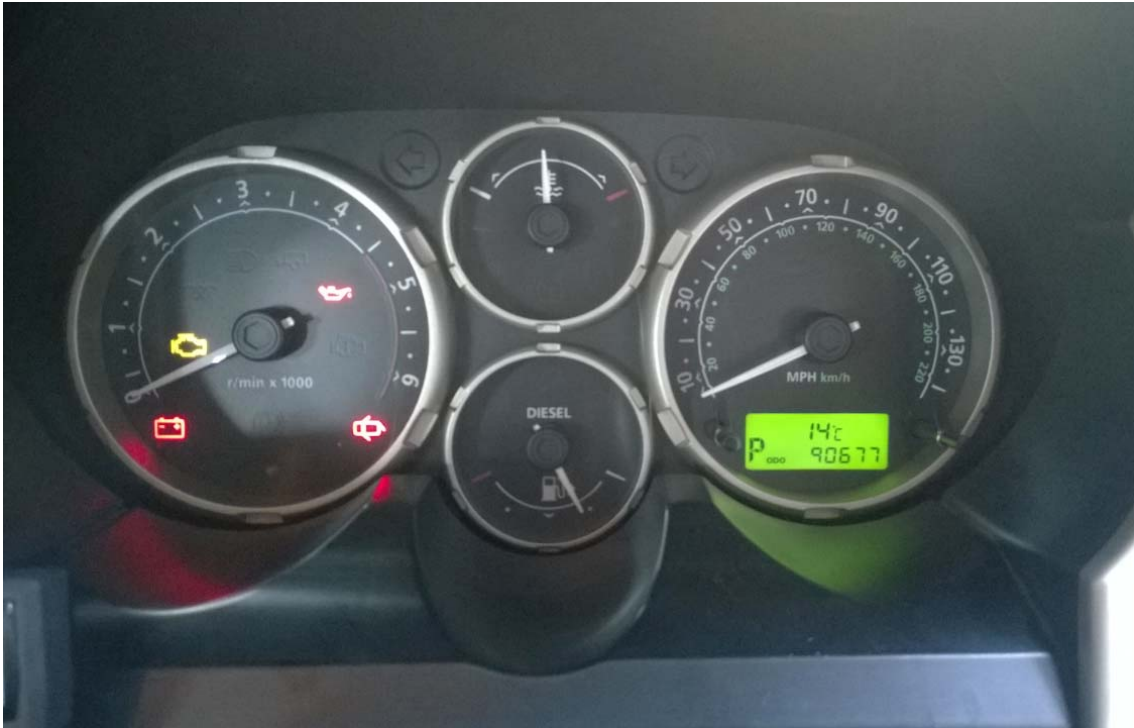
Now drive the car, and over a few miles driving the sensor reading will begin to change slowly. The sensor has set threshold defaults programmed in and will not function until these are exceeded. You should end up with this.
